Home Inspection Report
Prepared For:

Property Address:
1234 Easy Street
San Diego, CA 92101

Property Type:	Single Family
Stories:	One
Year Built:	1954
Bedrooms/Baths:	3/2
Door Faces:	South
Furnished:	Yes
Weather:	Sunny
Temperature:	Warm
Soil Condition:	Dry
Utilities On During Inspection:	Electric Service, Gas Service, Water Service
People Present:	Not Present
Inspection Fee:	\$465

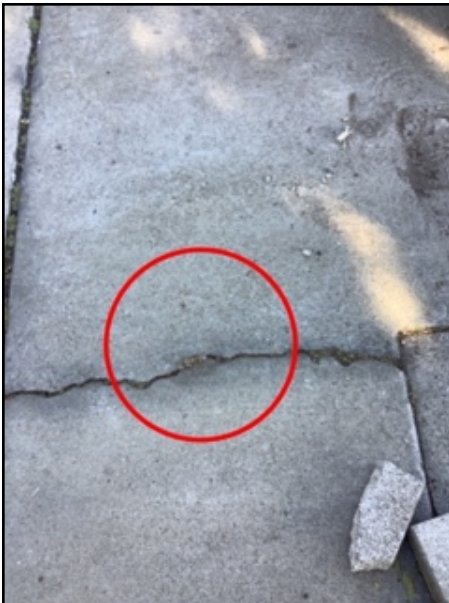
Figure 4-1

**Comment 4:**
Cracks, stains and uneven surfaces noted at driveway, walkways and patio.

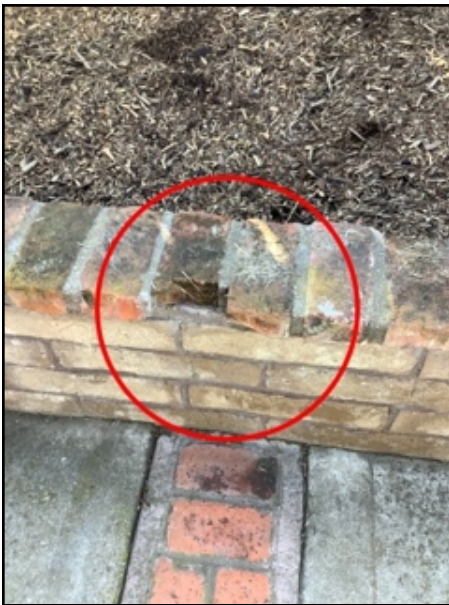
Figure 5-1

Repair or replace: Cracks and broken bricks noted in various locations on retaining wall.

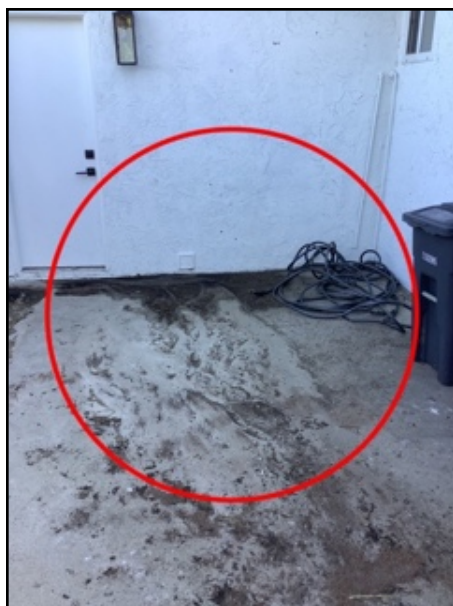
Figure 6-1

Repair or replace: East concrete patio noted as sloping towards structure. Evidence of erosion and ponding noted next to structure. Evidence of previous standing water noted around drain cover at rear patio.

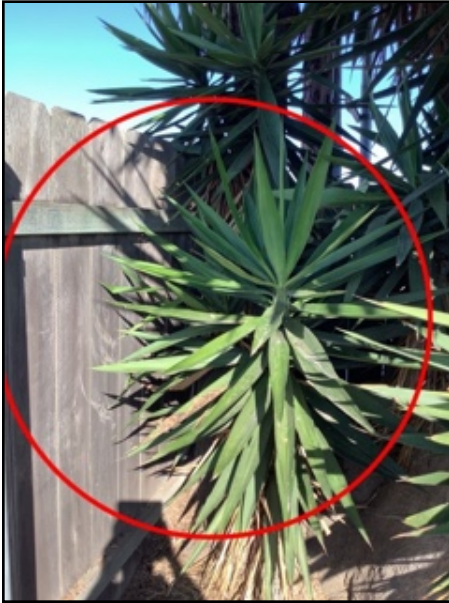
Figure 7-1

**Comment 7:**
Repair or replace: Vegetation noted as growing against fence in east corner.

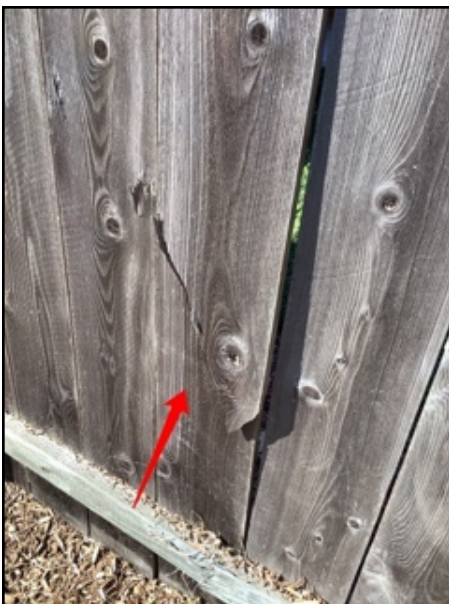
Figure 8-1

**Comment 8:**
Repair or replace: Loose boards, leaning, sunburned wood, broken boards , evidence of possible wood destroying organisms, improper repairs all noted on fence.

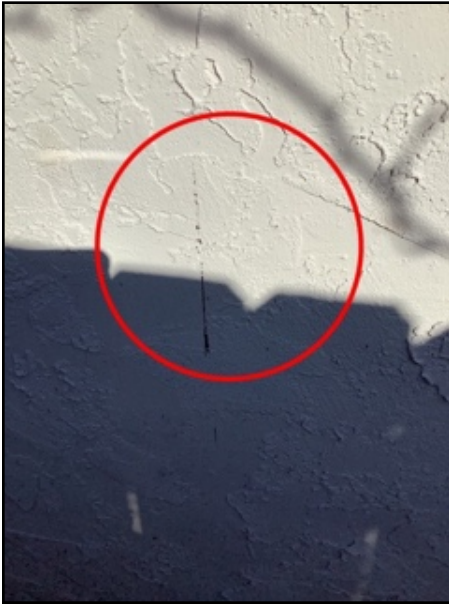
Figure 9-1

Comment 9:
Defects such as peeling, holes, cracks, and patches noted at various places throughout exterior.

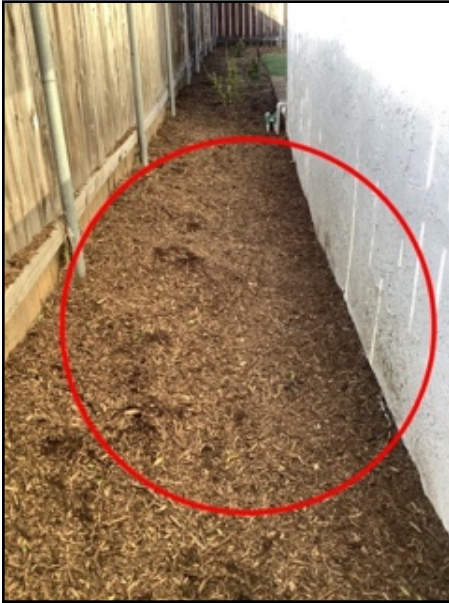
Figure 10-1

Repair or replace: Grading noted as sloping towards the structure on side yard.

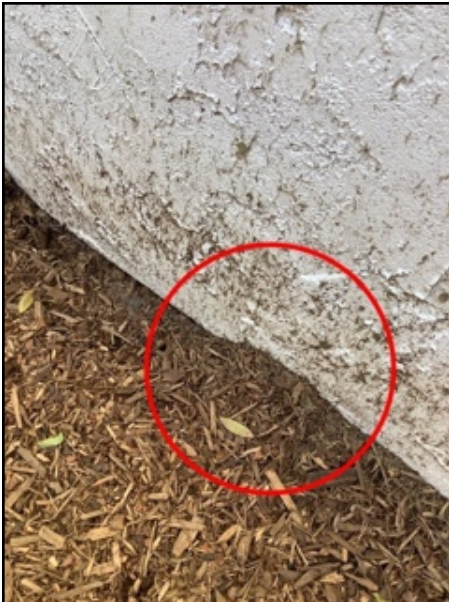
Figure 11-1

Repair or replace: Soil noted as making contact with the structure above the drip edge.

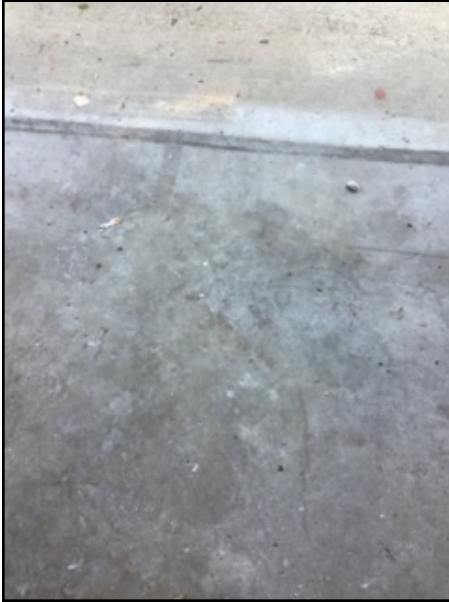
Figure 12-1

Cracks and stains noted at garage floor. Minor paint, drywall damage and other minor cosmetic defects noted at various locations throughout the garage.

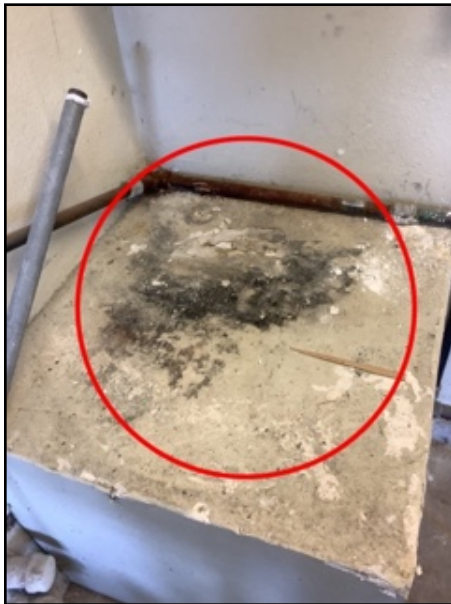
Figure 14-1

Further evaluation required: possible organic growth noted. Mold: Your home inspection agreement outlined the scope and duties of your home inspector with regard to potentially hazardous molds which may be discovered as part of today's inspection.

Moisture noted on water heater stand

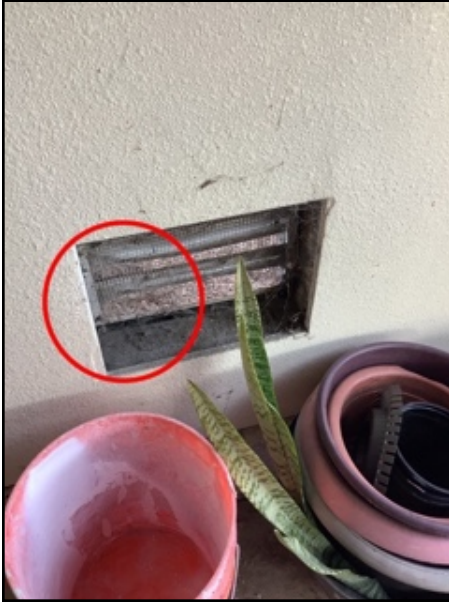
Figure 15-1

Repair or replace: Vent screen in garage noted as torn . This is a possible rodent entry area

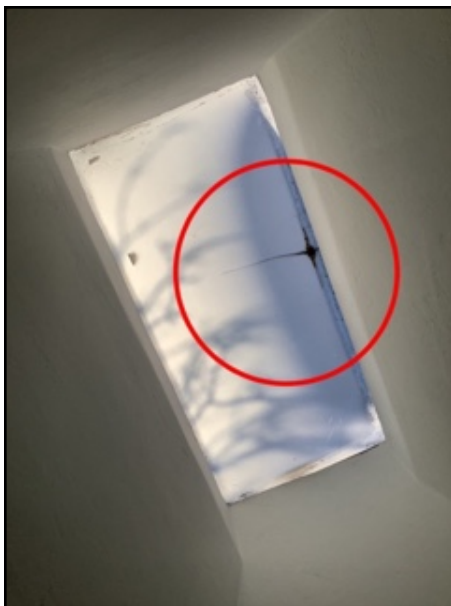
Figure 17-1

Repair or replace: Cracks and stains noted on skylight the interior.

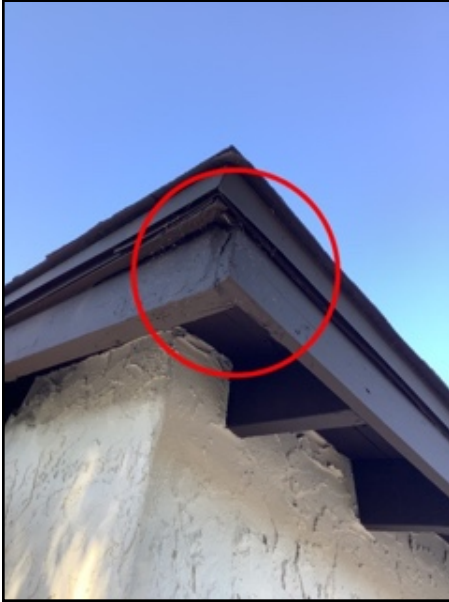
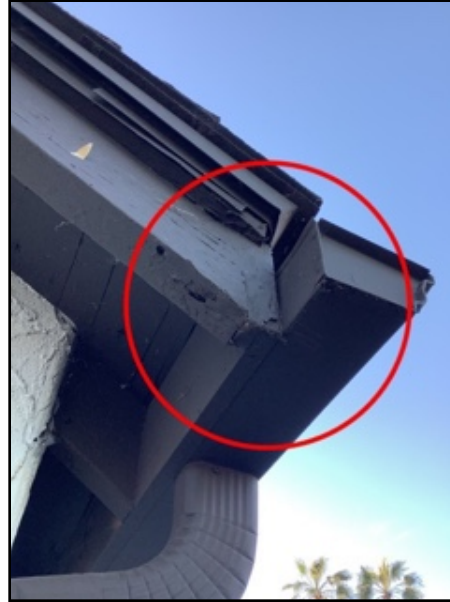
Further evaluation required: Evidence of possible wood destroying organisms noted on soffit and or fascia.

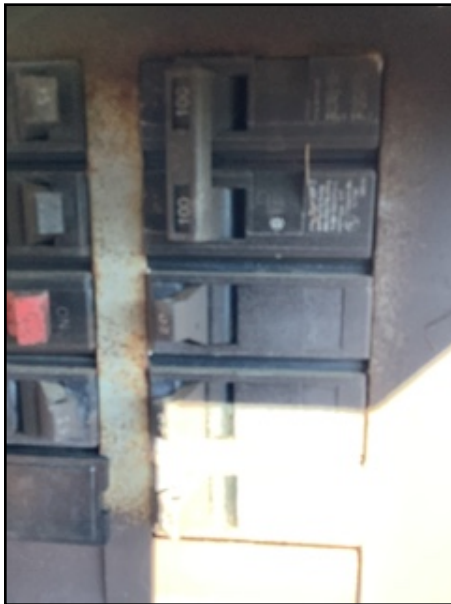
Figure 22-1

No labels for breakers at time of inspection. Breakers appear do you have been over sprayed with paint. No cover noted on electrical outlet in garage.

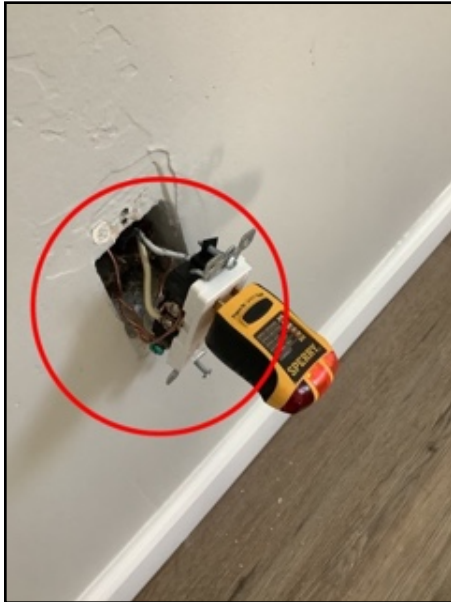
Figure 23-1

Repair or replace: wiring at service panel does not match outlet configuration. Some outlets have had the ground wire jumped to the neutral in order to create a false reading on an outlet tester. Outlet tester indicates the outlet is good. However, outlet and outlets downstream on the circuit are not grounded. Further evaluation by more qualified professional is required.

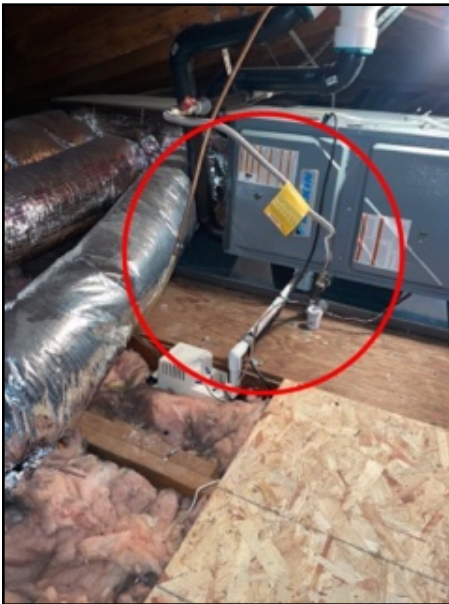
Figure 29-1

The home is plumbed for air conditioning but no unit is installed.

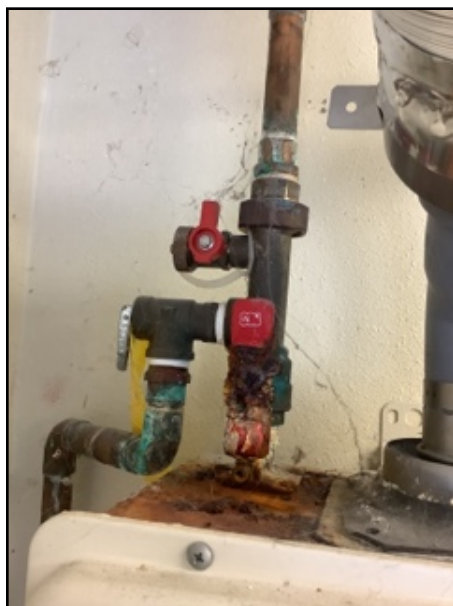
Figure 35-1

Repair or replace: Hot water valve noted as corroded .

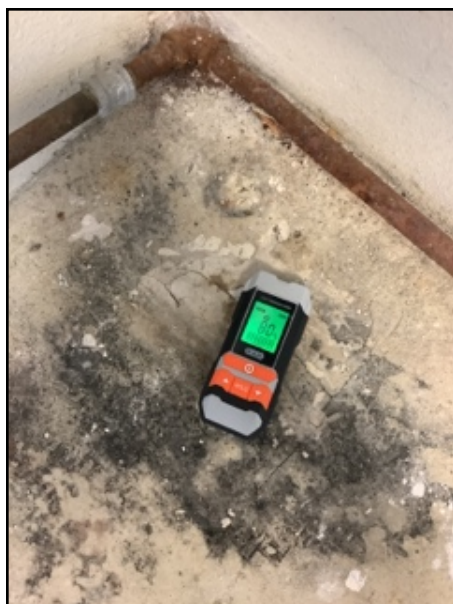
Figure 36-1

Repair or replace: condensation drainpipe noted as not attached to tankless water heater. Evidence of moisture noted on old water heater stand under tankless water heater

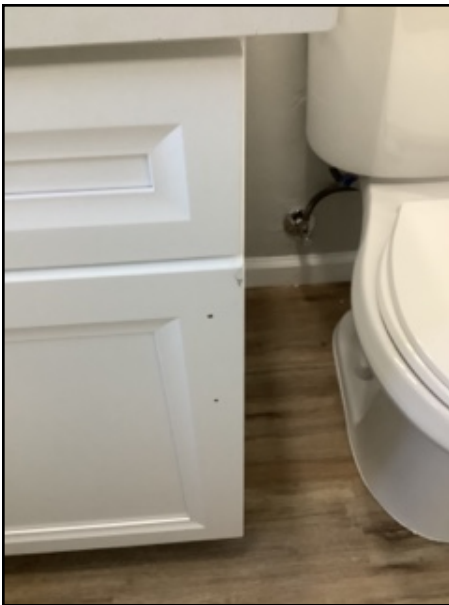
Figure 38-1

Repair or replace: Vanity noted as missing knobs.

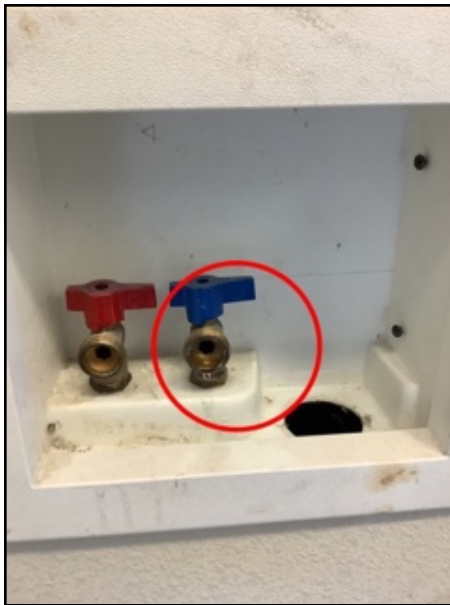
Figure 39-1

Comment 39:
Repair or replace: Cold water valve noted as leaking.

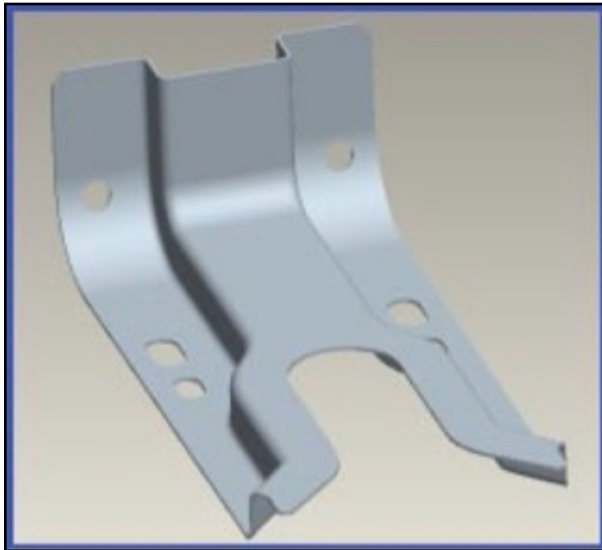
Figure 41-1

i Comment 41:
As of 2012 anti-tip devices are required to be installed on all new range installations. Age of range is unknown. Anti tip device not installed at range.

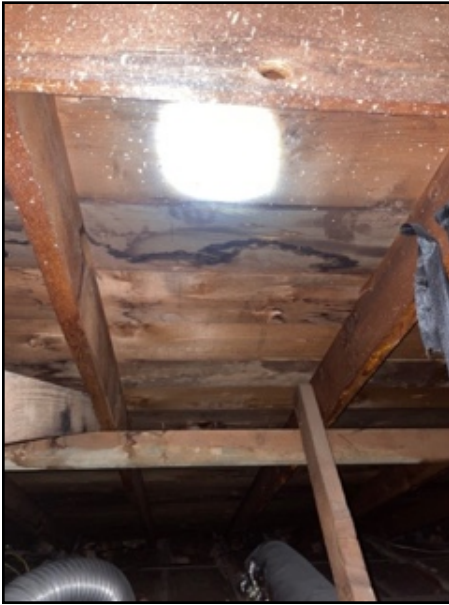
Figure 43-1

Previous water stains noted on roof deck at time of inspection

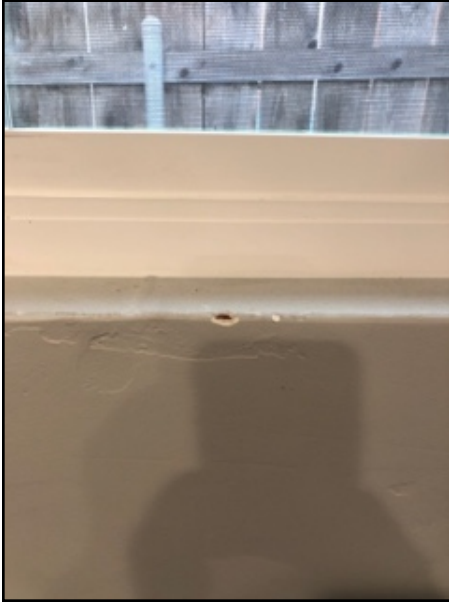
Figure 44-1

Minor paint, drywall damage, burned out bulbs, broken/missing covers and other minor cosmetic defects noted at various locations throughout the home.

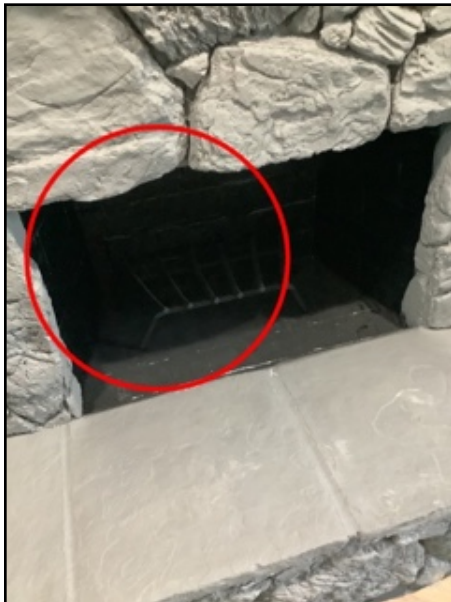
Figure 45-1

Repair or replace: door/screen noted as missing.

Chimney noted as dirty, clean before next use.

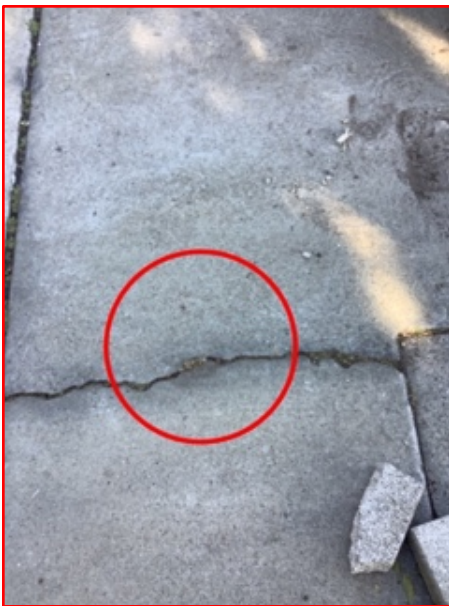
Figure 4-1

1) Comment 4: Cracks, stains and uneven surfaces noted at driveway, walkways and patio.

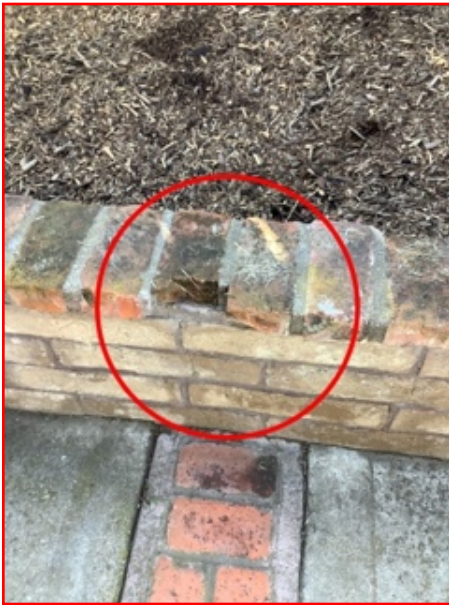
Figure 5-1

2) Comment 5: Repair or replace: Cracks and broken bricks noted in various locations on retaining wall.

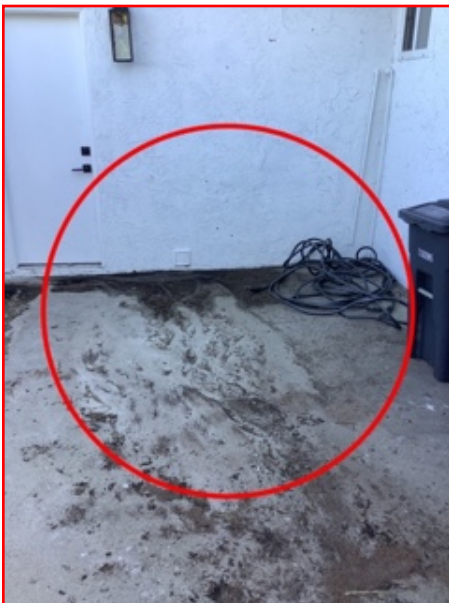
Figure 6-1

3) Comment 6: Repair or replace: East concrete patio noted as sloping towards structure. Evidence of erosion and ponding noted next to structure. Evidence of previous standing water noted around drain cover at rear patio.

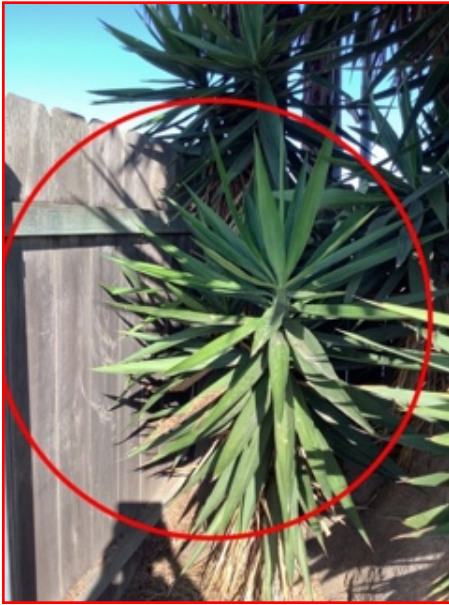
Figure 7-1

4) Comment 7: Repair or replace: Vegetation noted as growing against fence in east corner.

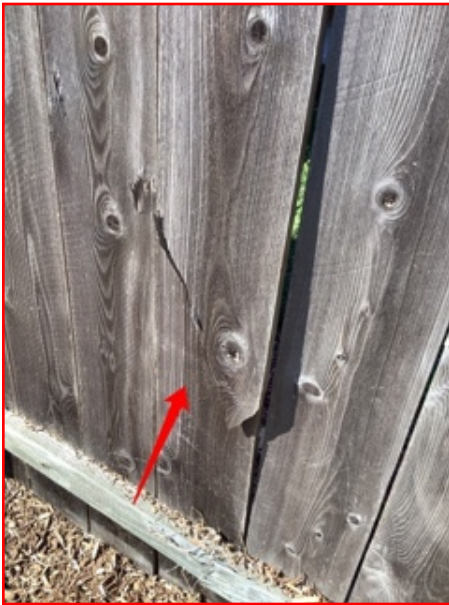
Figure 8-1

5) Comment 8: Repair or replace: Loose boards, leaning, sunburned wood, broken boards, evidence of possible wood destroying organisms, improper repairs all noted on fence.

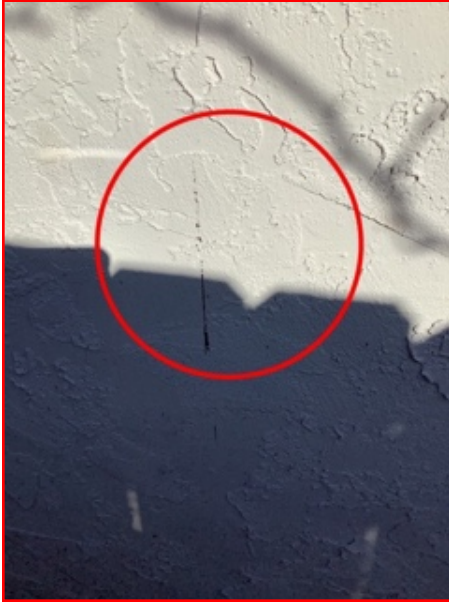
Figure 9-1

6) Comment 9: Defects such as peeling, holes, cracks, and patches noted at various places throughout exterior.

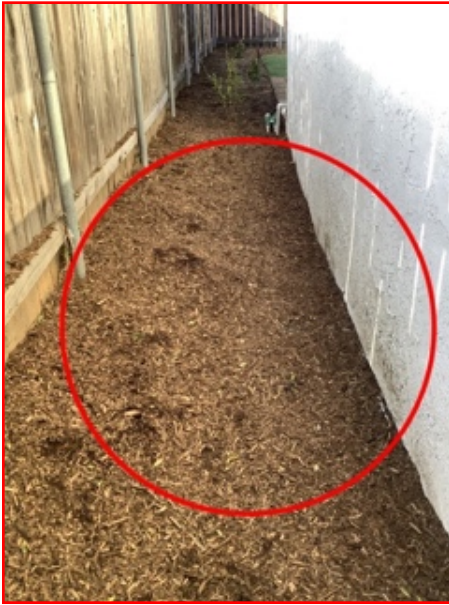
Figure 10-1

7) Comment 10: Repair or replace: Grading noted as sloping towards the structure on side yard.

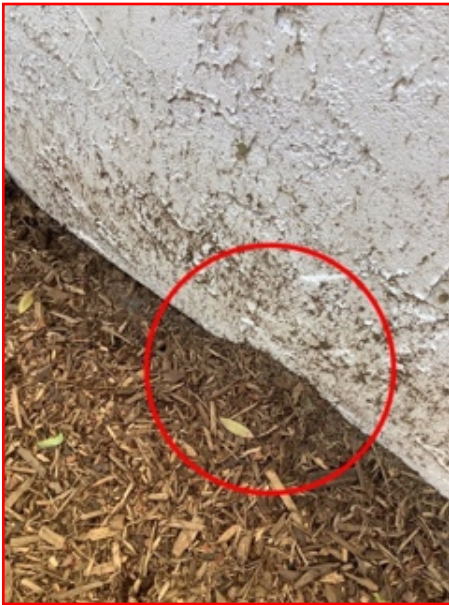
Figure 11-1

8) Comment 11: Repair or replace: Soil noted as making contact with the structure above the drip edge.

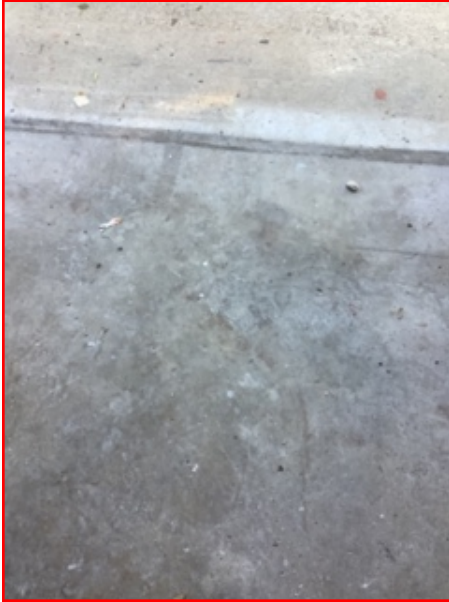
Figure 12-1

9) Comment 12: Cracks and stains noted at garage floor. Minor paint, drywall damage and other minor cosmetic defects noted at various locations throughout the garage.

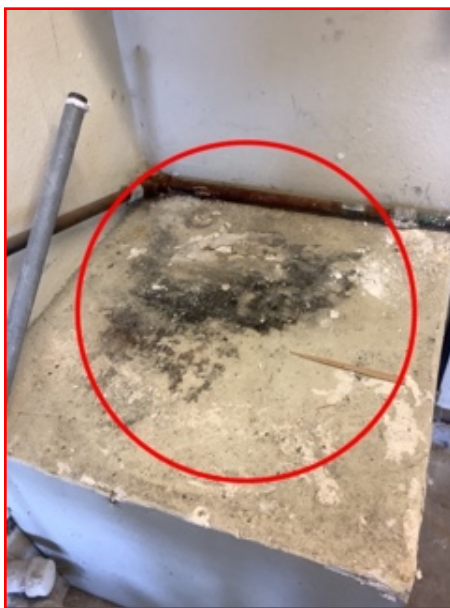
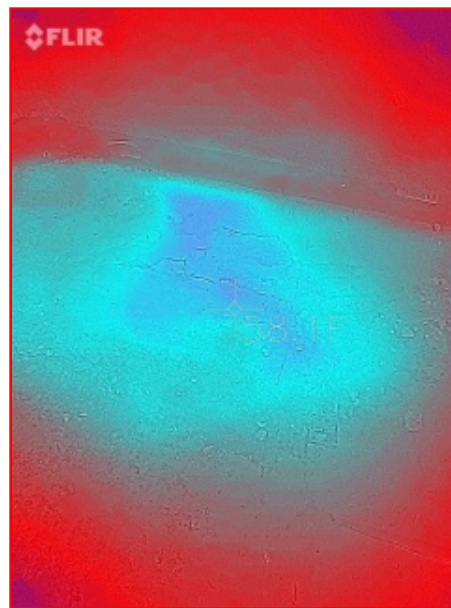
Moisture noted on water heater stand

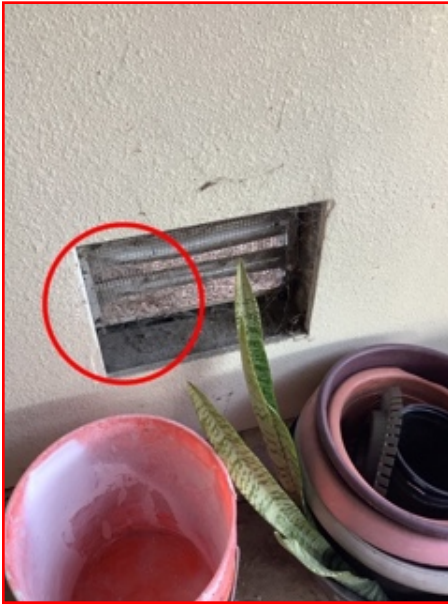
Figure 15-1

11) Comment 15: Repair or replace: Vent screen in garage noted as torn . This is a possible rodent entry area

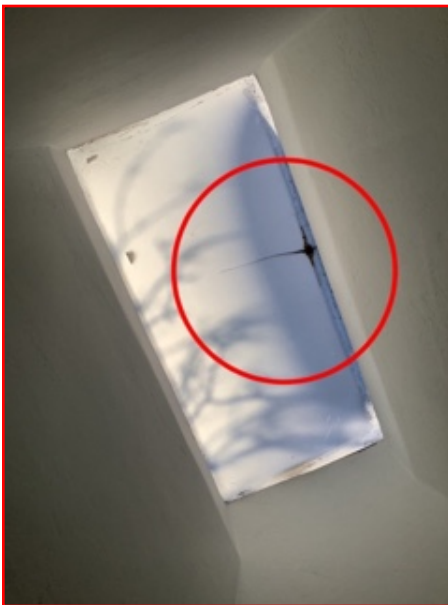
Figure 17-1

12) Comment 17: Repair or replace: Cracks and stains noted on skylight the interior.

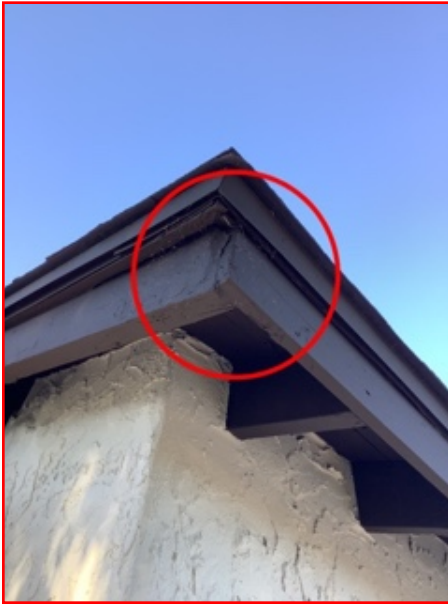
Figure 18-1

13) Comment 18: Further evaluation required: Evidence of possible wood destroying organisms noted on soffit and or fascia.

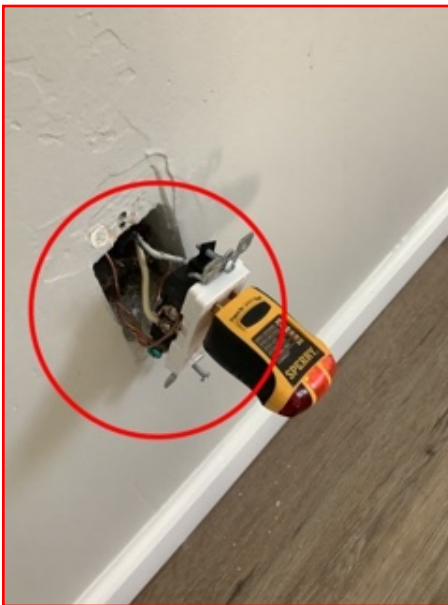
Figure 23-1

14) Comment 23: Repair or replace: wiring at service panel does not match outlet configuration. Some outlets have had the ground wire jumped to the neutral in order to create a false reading on an outlet tester. Outlet tester indicates the outlet is good. However, outlet and outlets downstream on the circuit are not grounded. Further evaluation by more qualified professional is required.

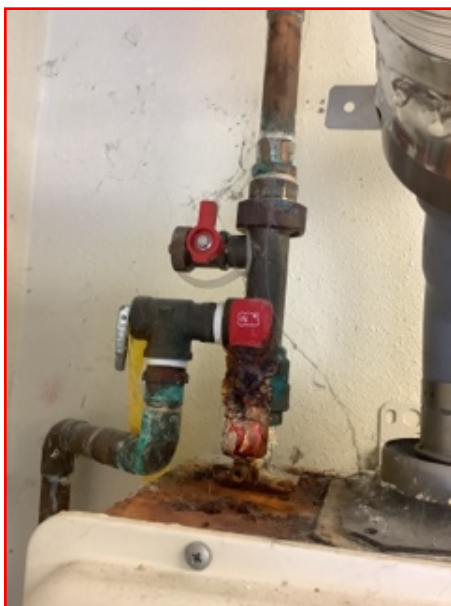
Figure 35-1

15) Comment 35: Repair or replace: Hot water valve noted as corroded .

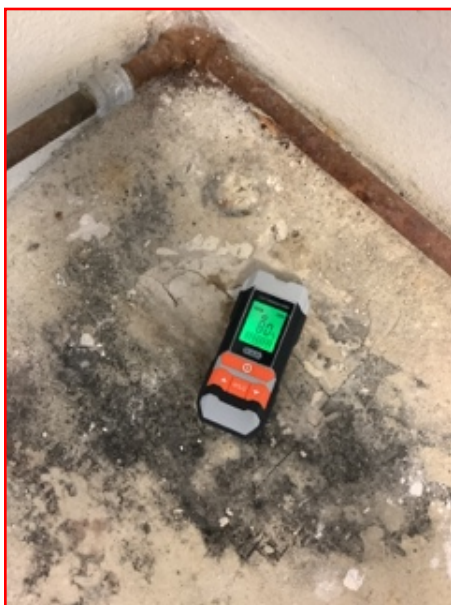
Figure 36-1

16) Comment 36: Repair or replace: condensation drainpipe noted as not attached to tankless water heater. Evidence of moisture noted on old water heater stand under tankless water heater

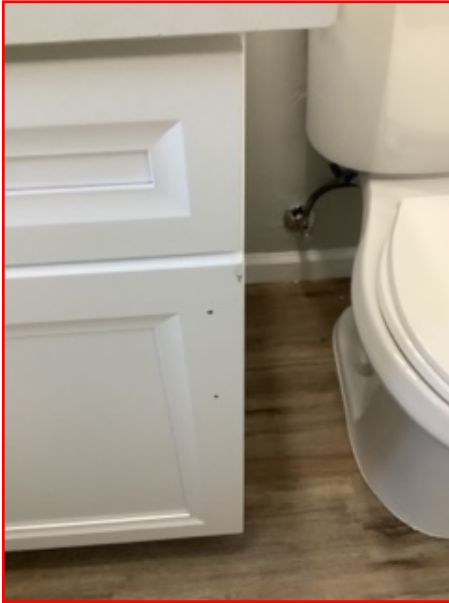
Figure 38-1

17) Comment 38: Repair or replace: Vanity noted as missing knobs.

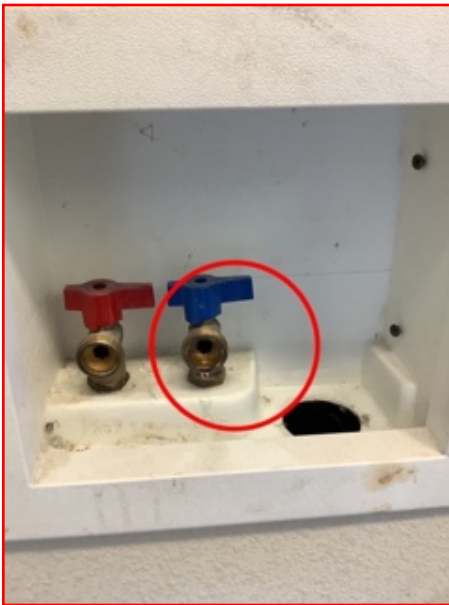
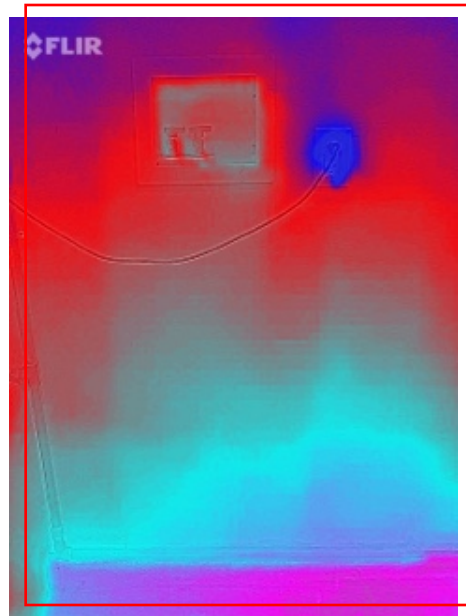
18) Comment 39: Repair or replace: Cold water valve noted as leaking.

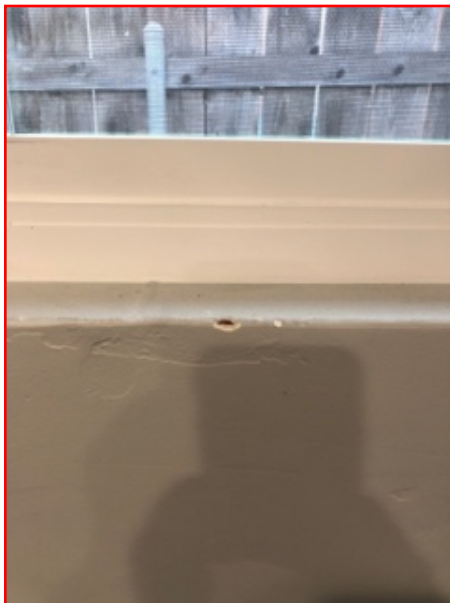
Figure 44-1

19) Comment 44: Minor paint, drywall damage, burned out bulbs, broken/missing covers and other minor cosmetic defects noted at various locations throughout the home.

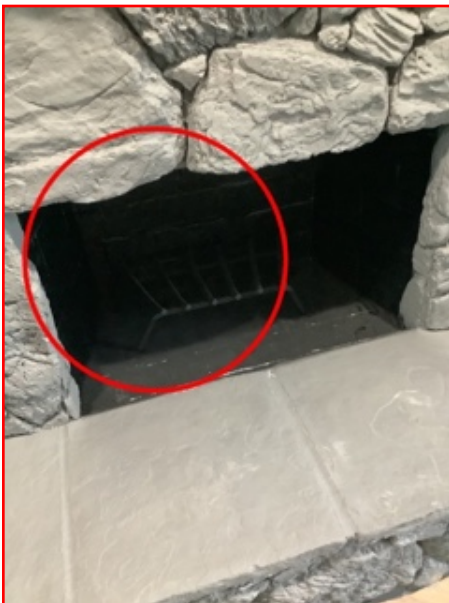
Figure 45-1

20) Comment 45: Repair or replace: door/screen noted as missing.

Chimney noted as dirty, clean before next use.
