Home Inspection Report
Prepared For:

Property Address:
1234 Easy Street
San Diego, CA 92101

Property Type:	Single Family
Stories:	One
Year Built:	1954
Bedrooms/Baths:	3/2
Door Faces:	South
Furnished:	Yes
Weather:	Sunny
Temperature:	Warm
Soil Condition:	Dry
Utilities On During Inspection:	Electric Service, Gas Service, Water Service
People Present:	Not Present
Inspection Fee:	\$465

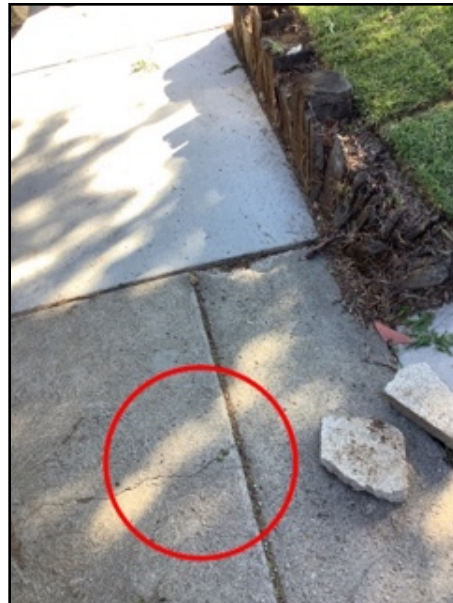
Figure 4-2

**Comment 4:**
Cracks, stains and uneven surfaces noted at driveway, walkways and patio.

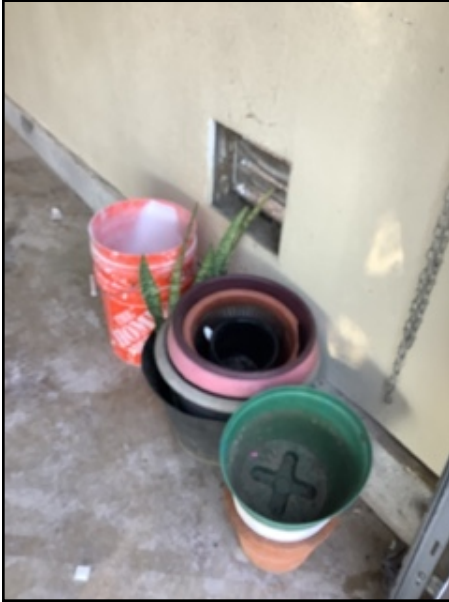
Figure 13-1

Personal belongings stored in garage prevented inspection of some aspects of the garage.

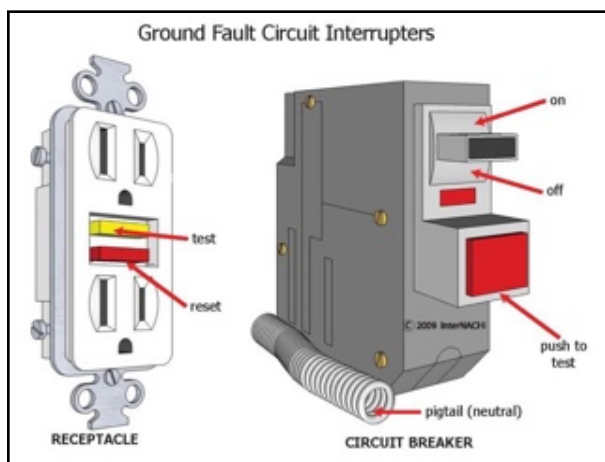
Figure 19-1

Although it may not have been required when this home was originally built, whenever outlets are replaced it is required to have GFCI outlets installed near water/ high humidity sources such as exterior, bathrooms and kitchens. It is beyond the scope of this report to check building code requirements for GFCI installation at each location. Client may choose to upgrade any non-protected outlets for additional safety.

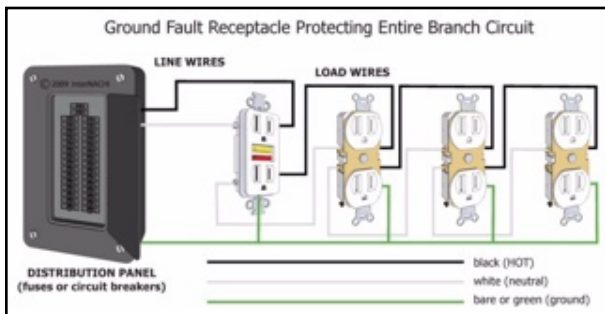
Figure 20-1

GFCI outlets protect all downstream Outlets in the circuit. A push button reset is not required location. It is outside the scope of this inspection to locate the push button reset for outlets that are required to be protected as set forth in the IRC.

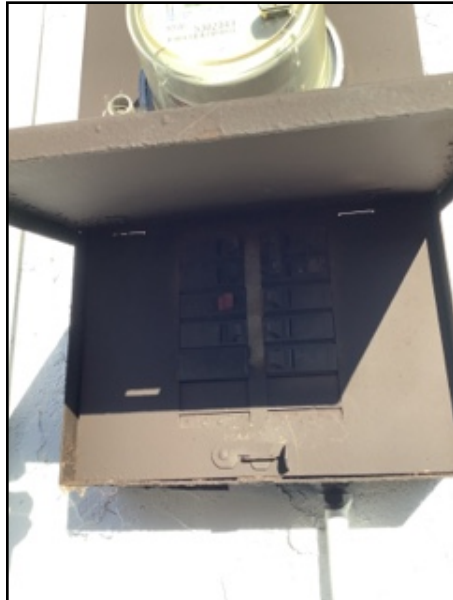
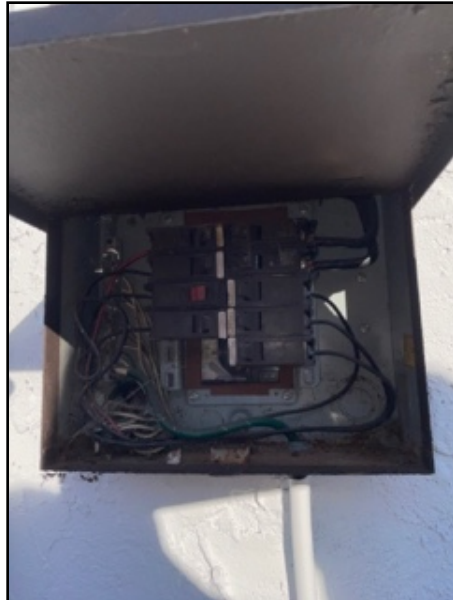
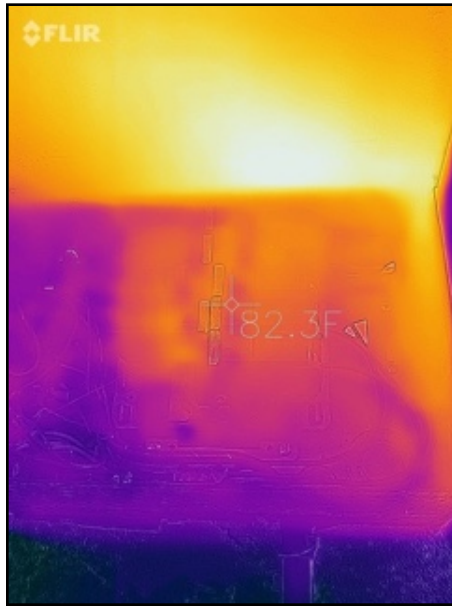
Service panel inspection pictures. A thermal scan was conducted and no significant hotspots were noted.

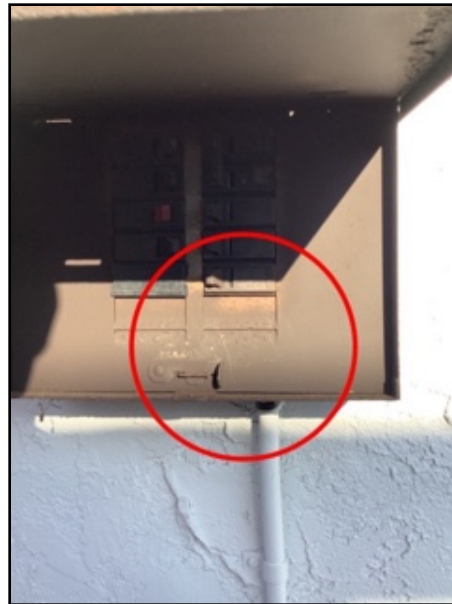
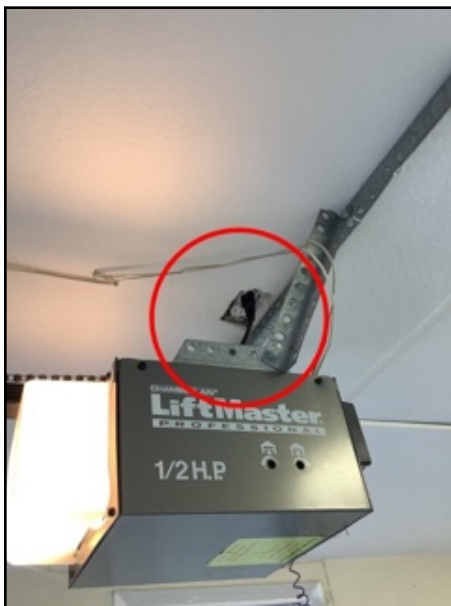
No labels for breakers at time of inspection. Breakers appear do you have been over sprayed with paint. No cover noted on electrical outlet in garage.

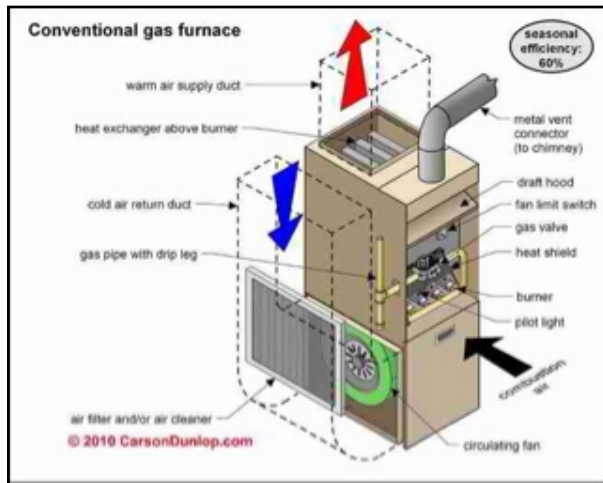
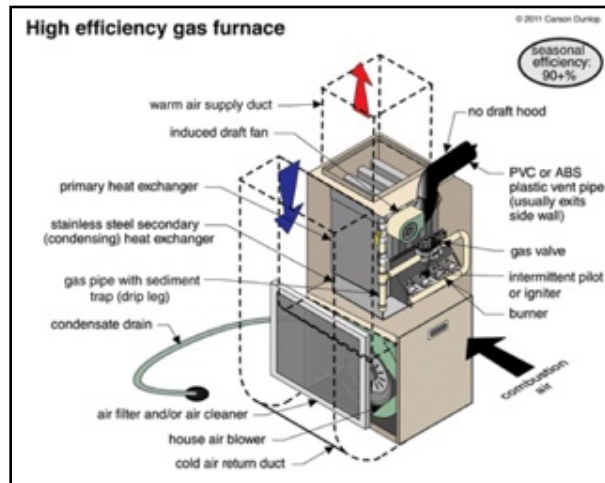
HVAC systems require annual maintenance to operate efficiently and prevent sanitary issues. Researching documentation regarding the most recent maintenance on this system is beyond the scope of this inspection and needs to be conducted by client.

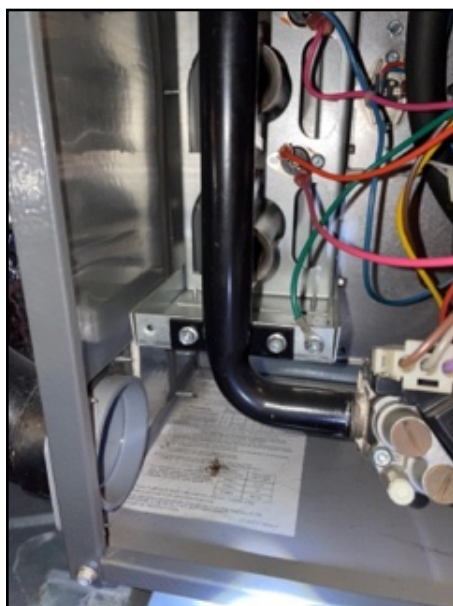
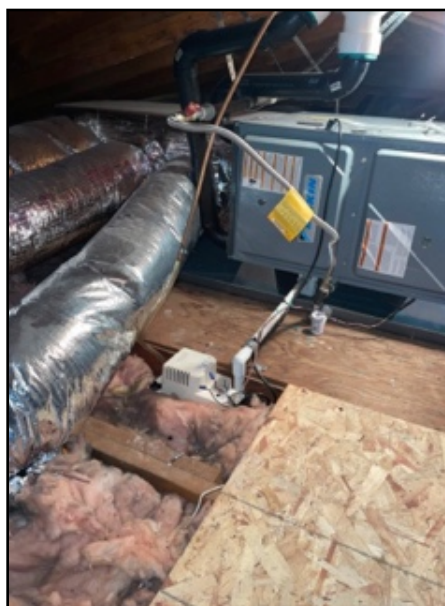
Furnace data plate picture.

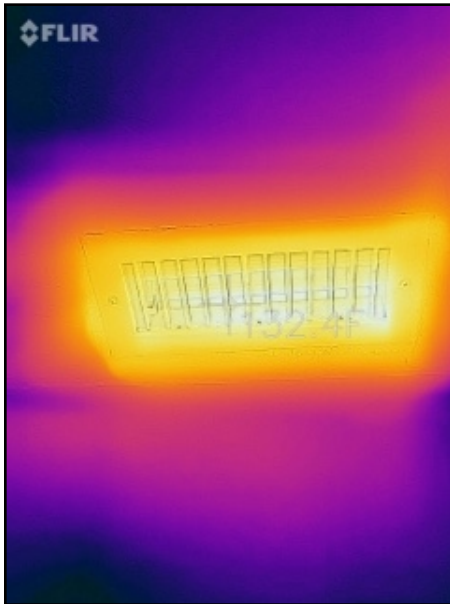
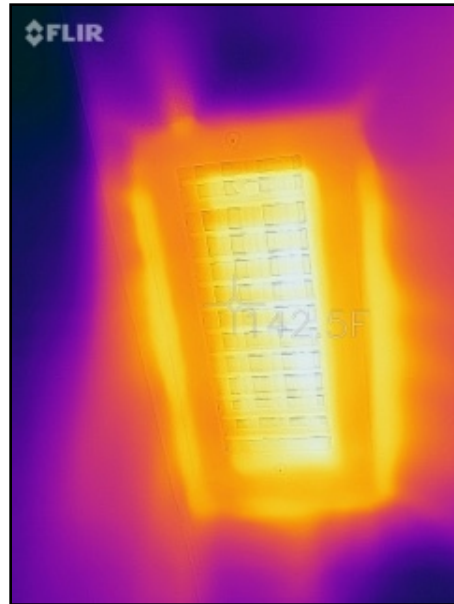
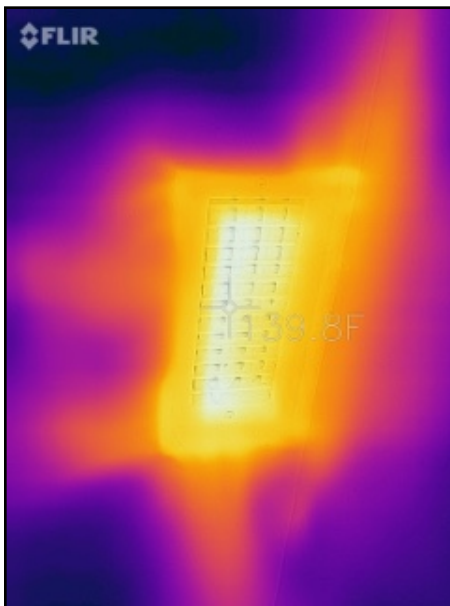
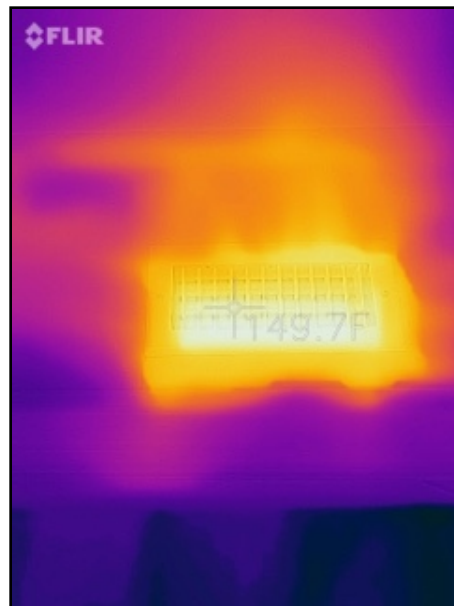
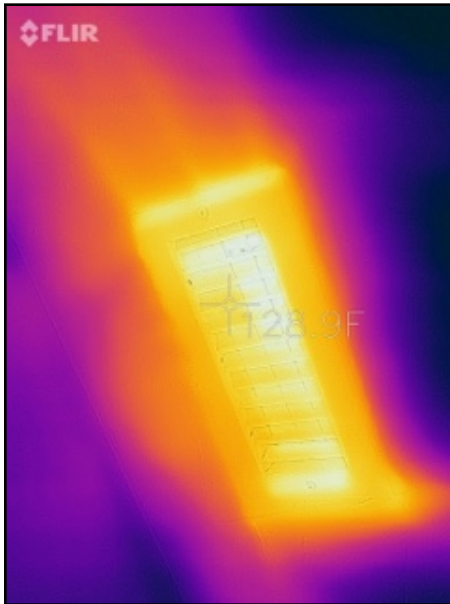
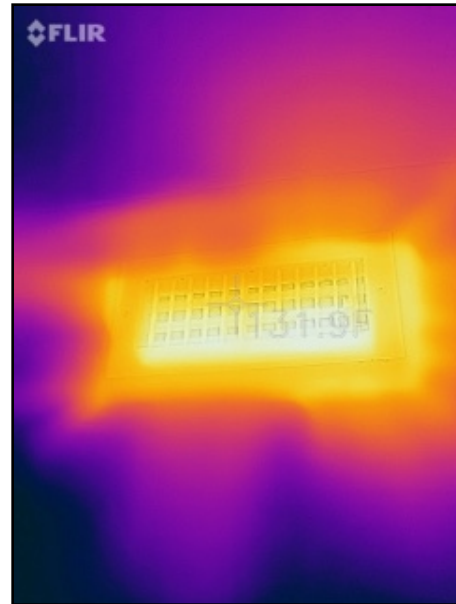
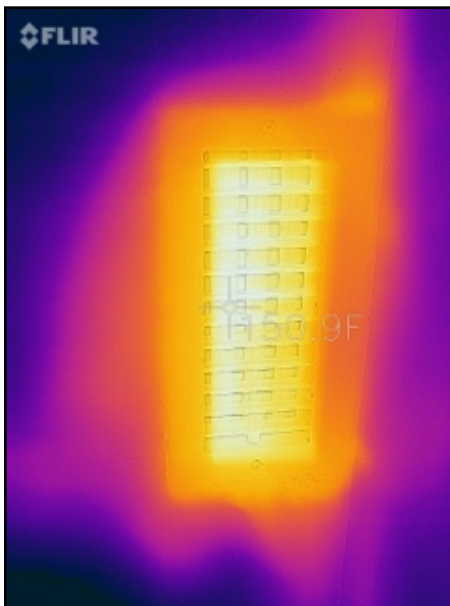
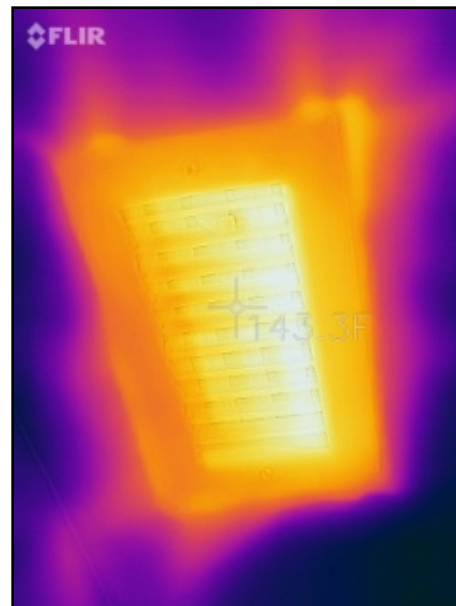
Comment 27:
Furnace thermal temperatures.

Furnaces over 10 years old should be checked, cleaned and serviced yearly by a licensed contractor.

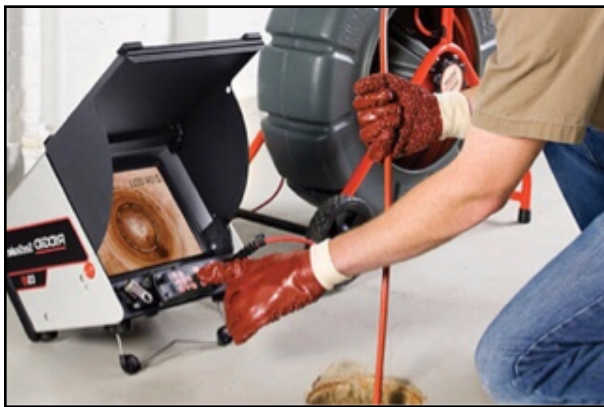
Figure 30-1

Visible and apparent leaks are noted under separate comments. In order to see the inside of drain lines the main sewer line may be inspected by a qualified technician with modern endoscopic video equipment.

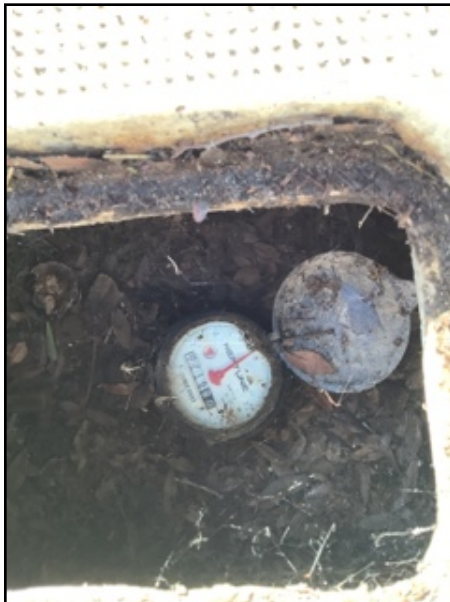
Figure 32-1

Comment 32:
Water meters with leak detectors.

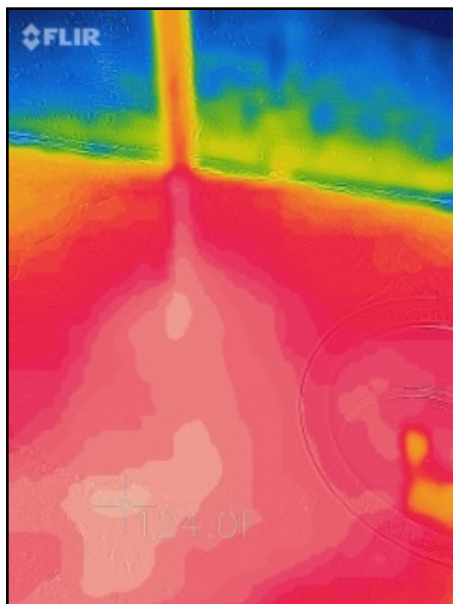
Figure 33-1

Water temperature was 124° F. Most appliance manufacturers recommend a temperature of around 120F. Generally temperatures above 130°F are considered unsafe.

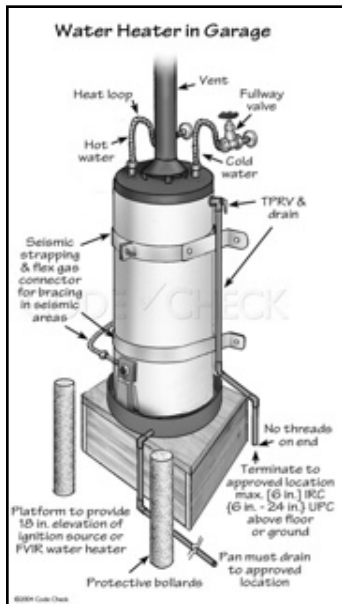
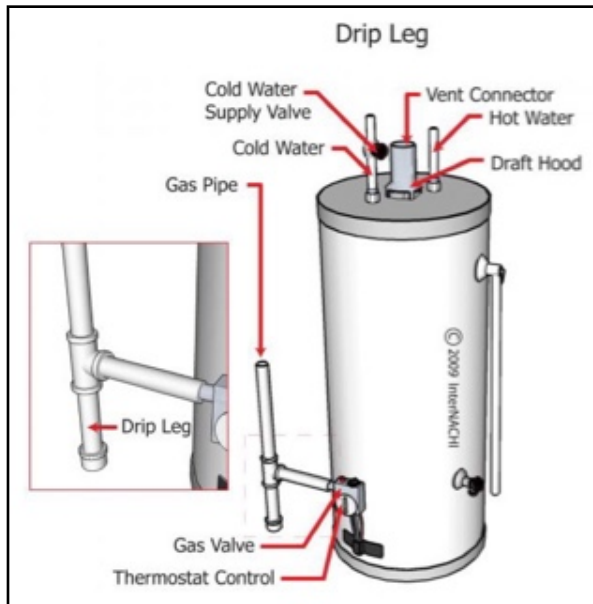
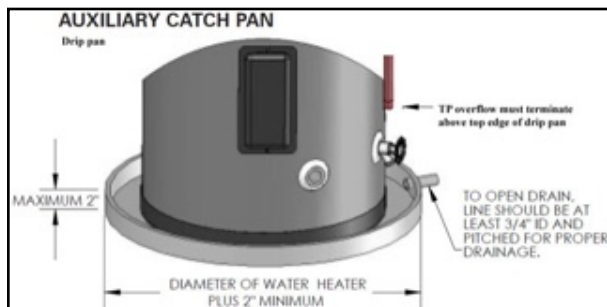
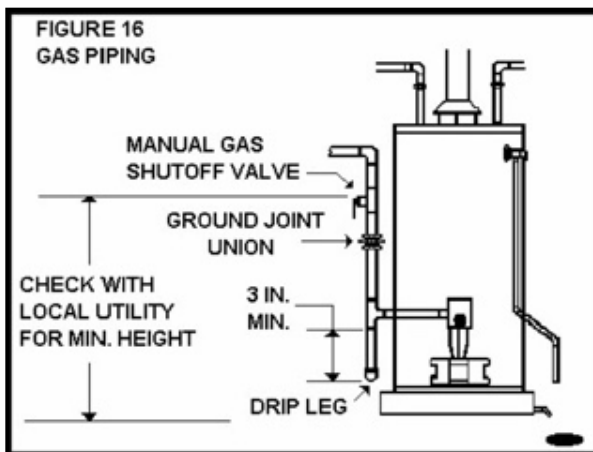
Examples of modern water heater installation requirements. Your water heater may have none, some, or all of these components depending on when it was installed.

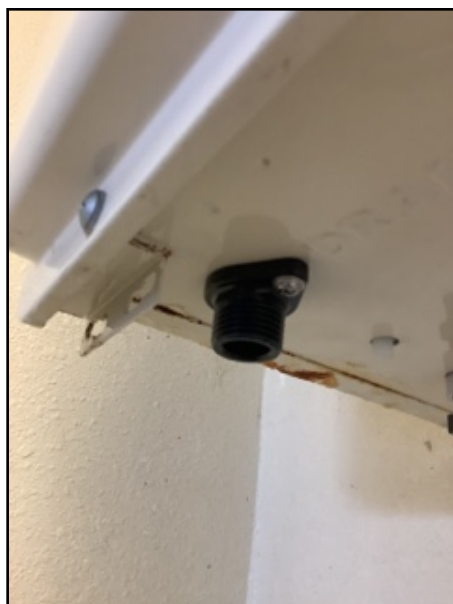
Figure 36-2

Repair or replace: condensation drainpipe noted as not attached to tankless water heater. Evidence of moisture noted on old water heater stand under tankless water heater

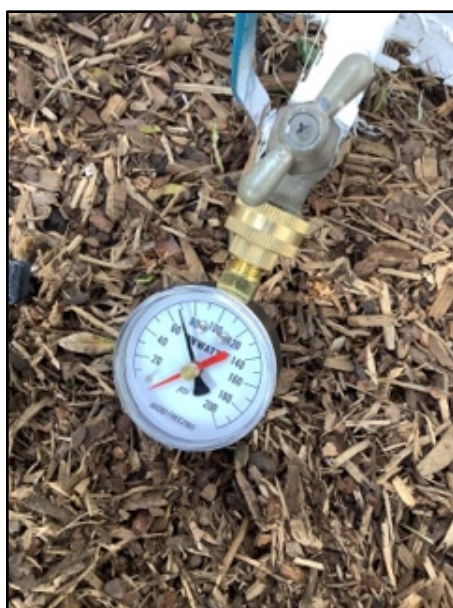
Figure 37-1

Water pressure is 70 psi. Most appliance manufacturers recommend pressure to be set between 50 and 80 psi.

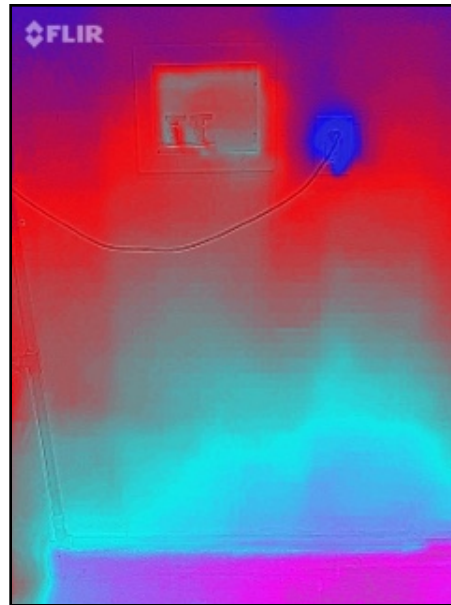
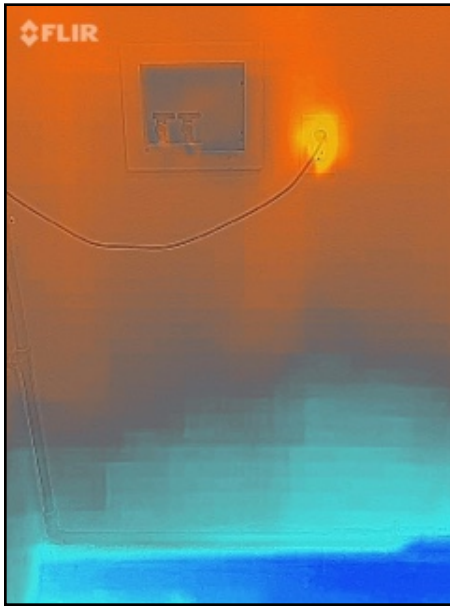
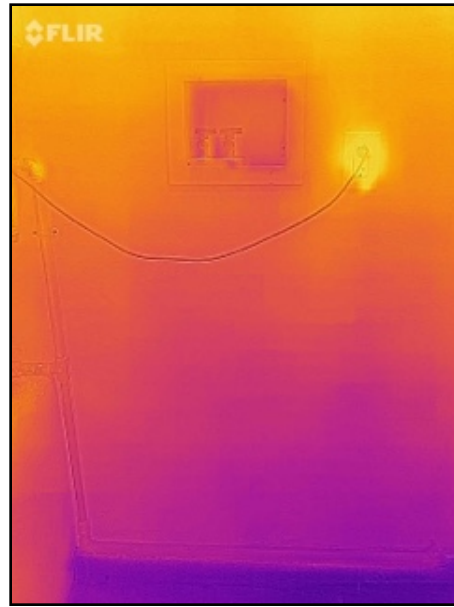
Comment 39:
Repair or replace: Cold water valve noted as leaking.

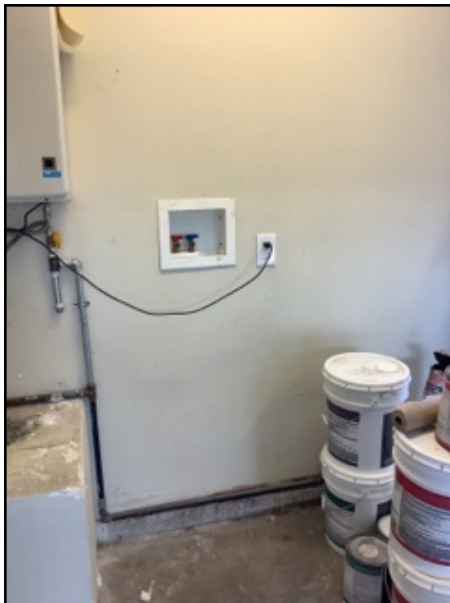
Figure 40-1

Comment 40:
Washer/dryer not present. Laundry hookups were visually inspected but not operated.

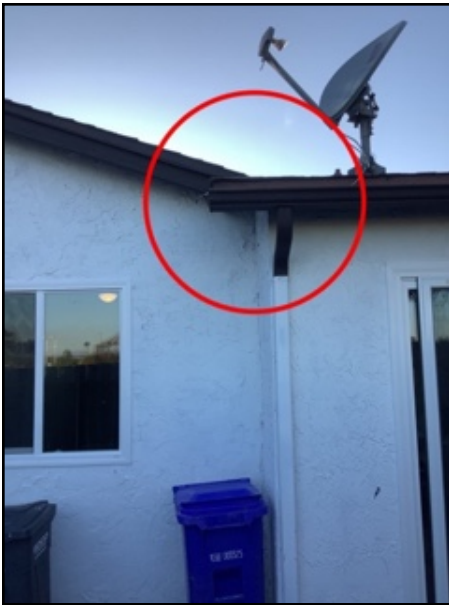
Figure 42-1

Apparent additions, extensions or conversions are present. It is outside the scope of this report to determine if permits were obtained, if the space meets current code and if the space is suitable for habitation.

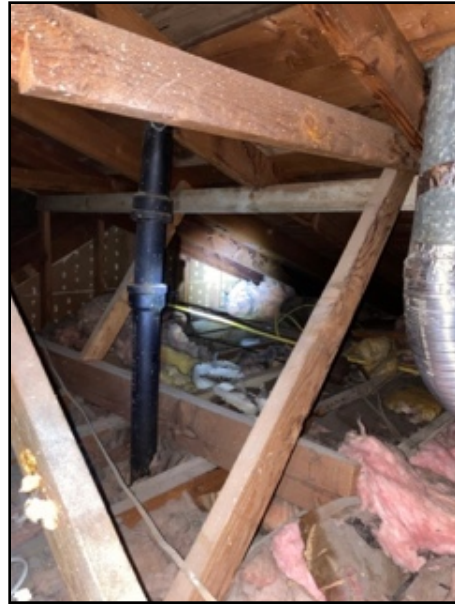
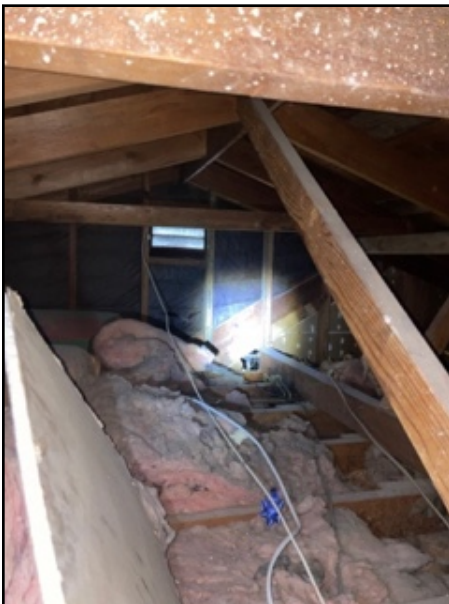
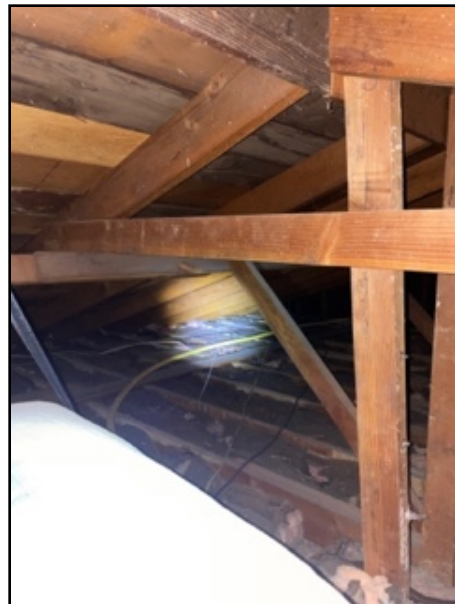
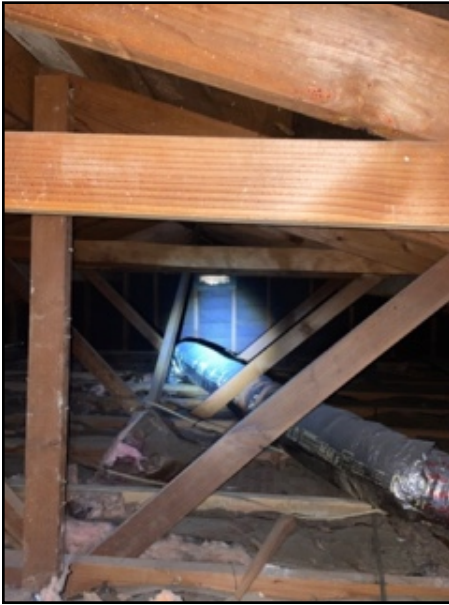
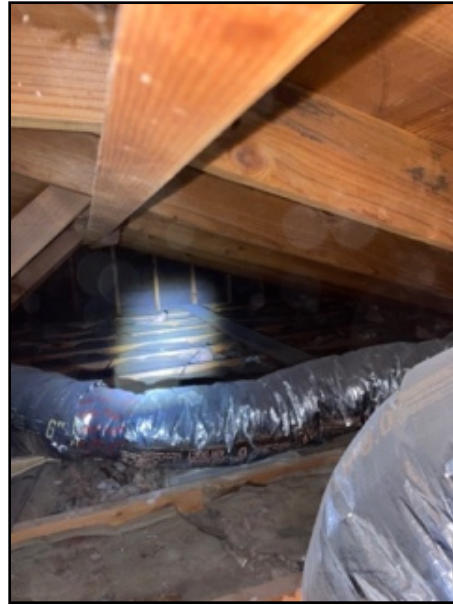
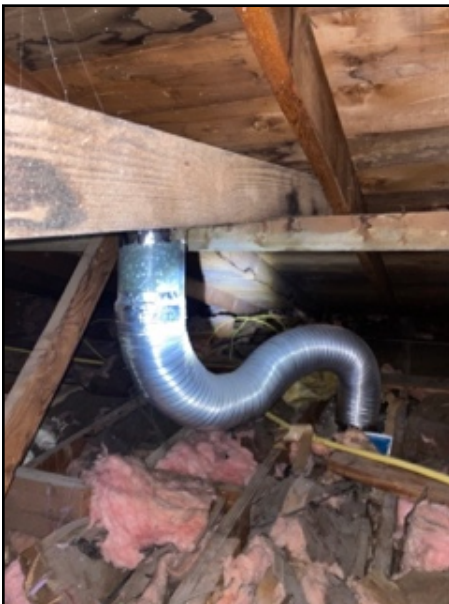
Previous water stains noted on roof deck at time of inspection

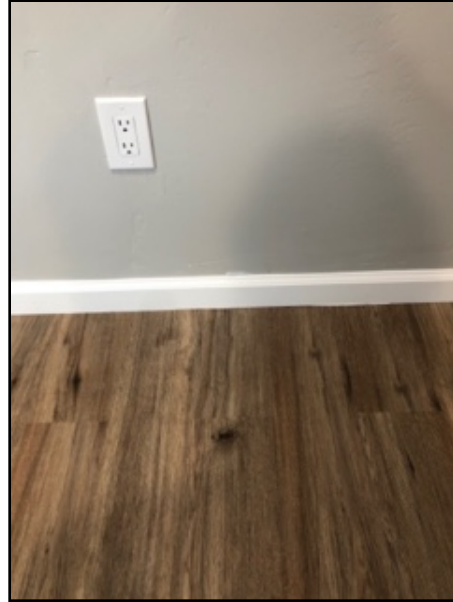
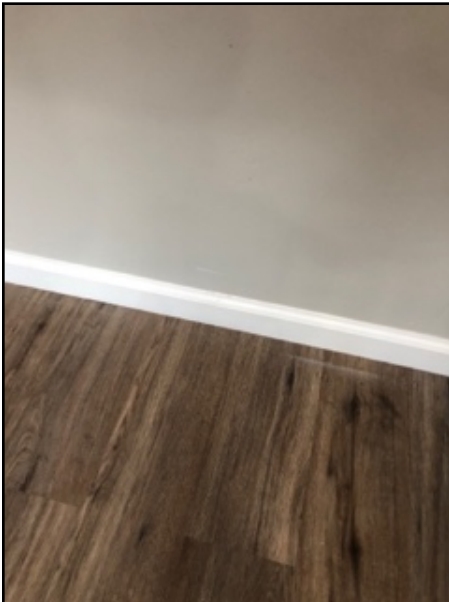
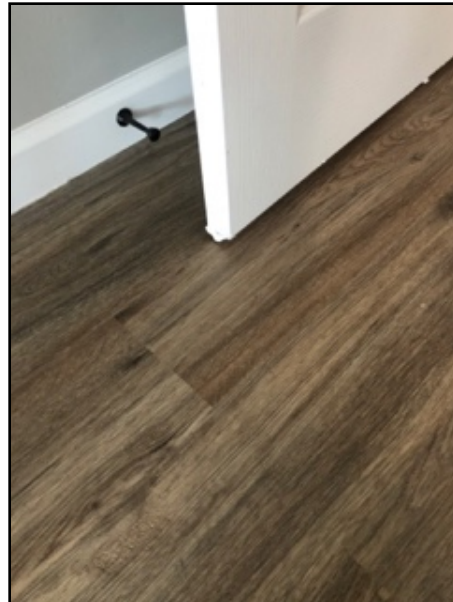
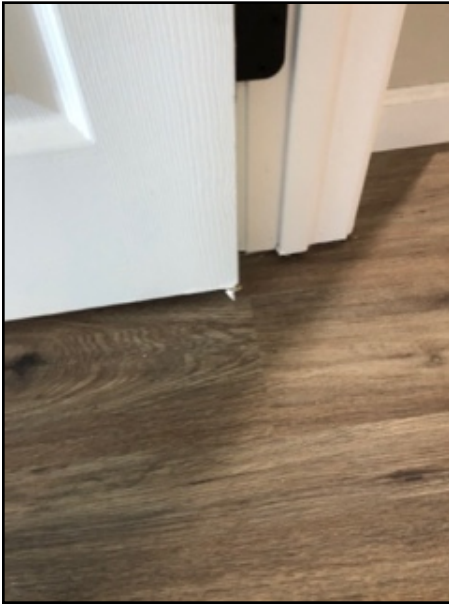
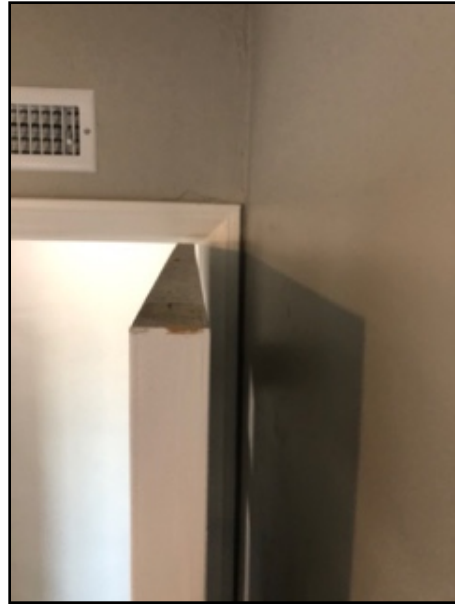
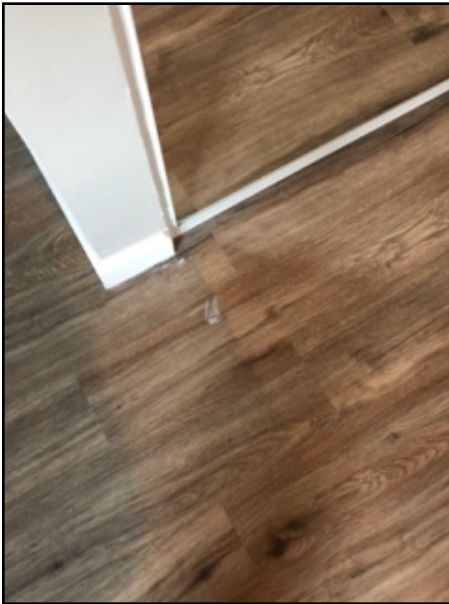
Minor paint, drywall damage, burned out bulbs, broken/missing covers and other minor cosmetic defects noted at various locations throughout the home.

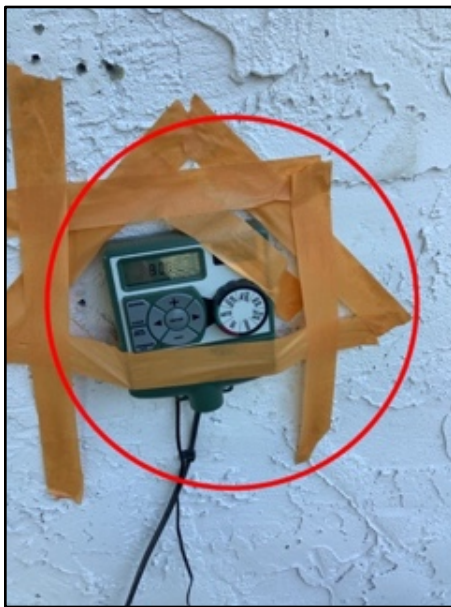
Figure 46-1

Lawn sprinklers were manually operated at valves. No apparent leaks or broken sprinkler heads were noted. It is beyond the scope of this report to inspect timers or non-visible electronic components.

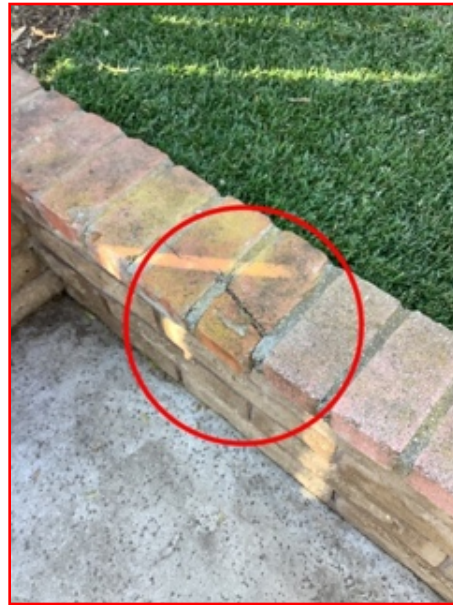
Figure 5-2

2) Comment 5: Repair or replace: Cracks and broken bricks noted in various locations on retaining wall.

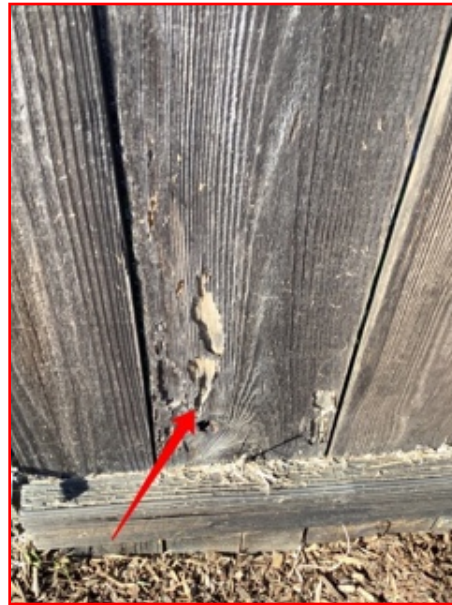
Figure 8-2

5) Comment 8: Repair or replace: Loose boards, leaning, sunburned wood, broken boards, evidence of possible wood destroying organisms, improper repairs all noted on fence.

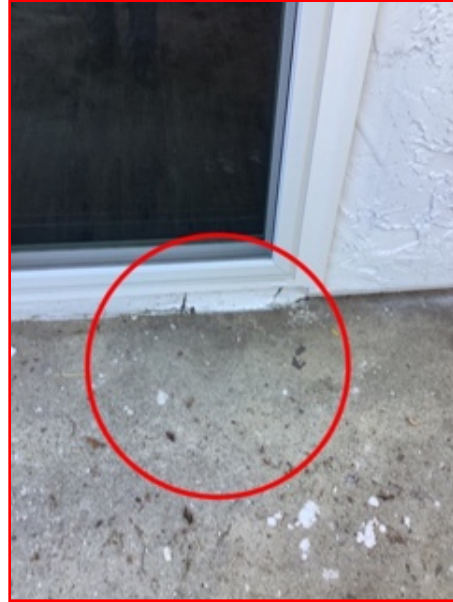
Figure 9-2

6) Comment 9: Defects such as peeling, holes, cracks, and patches noted at various places throughout exterior.

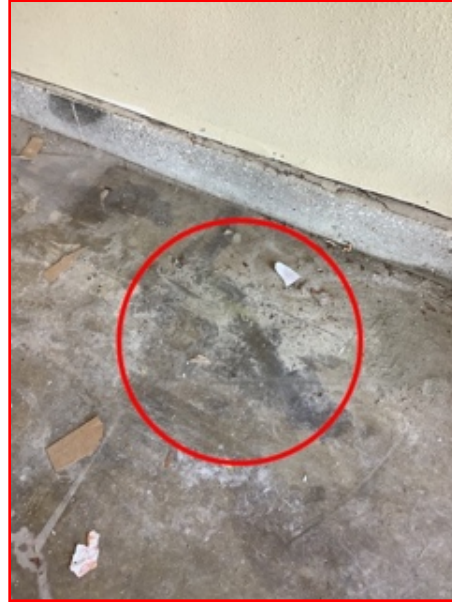
Figure 12-2

9) Comment 12: Cracks and stains noted at garage floor. Minor paint, drywall damage and other minor cosmetic defects noted at various locations throughout the garage.

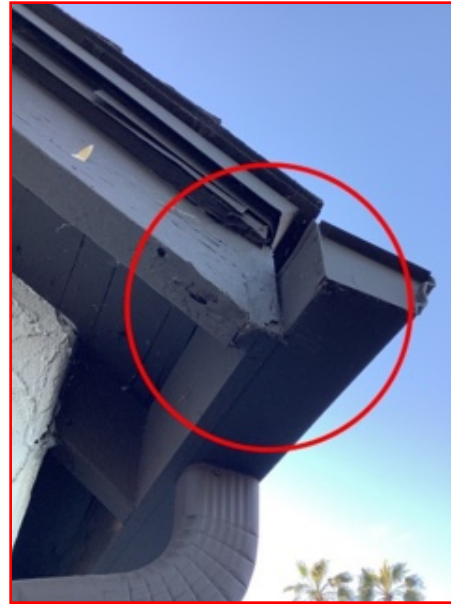
Figure 18-2

13) Comment 18: Further evaluation required: Evidence of possible wood destroying organisms noted on soffit and or fascia.

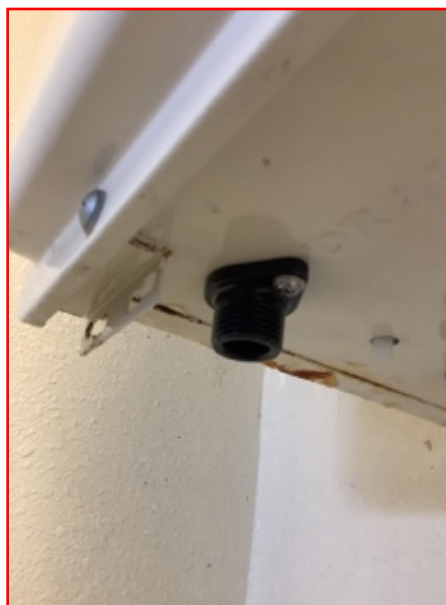
Figure 36-2

16) Comment 36: Repair or replace: condensation drainpipe noted as not attached to tankless water heater. Evidence of moisture noted on old water heater stand under tankless water heater

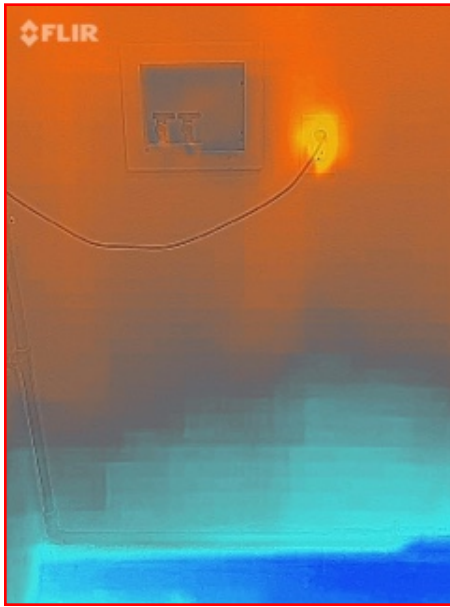
Figure 39-3

18) Comment 39: Repair or replace: Cold water valve noted as leaking.

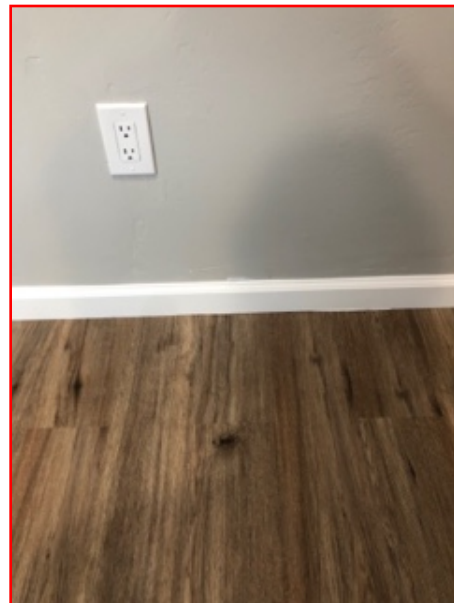
Figure 44-2

19) Comment 44: Minor paint, drywall damage, burned out bulbs, broken/missing covers and other minor cosmetic defects noted at various locations throughout the home.
